SMOKE TESTING OBSERVATION SUMMARY

Western Run Pilot Project - Baltimore Maryland

Unique Test ID	218	Date:	10/5/2004	MeterBasin:	01_WR07
Observer ID:	B	Crew:	T-2	Dye Test Recommended:	N
Defect No:	5	Setup No:	3	Priority CCTV:

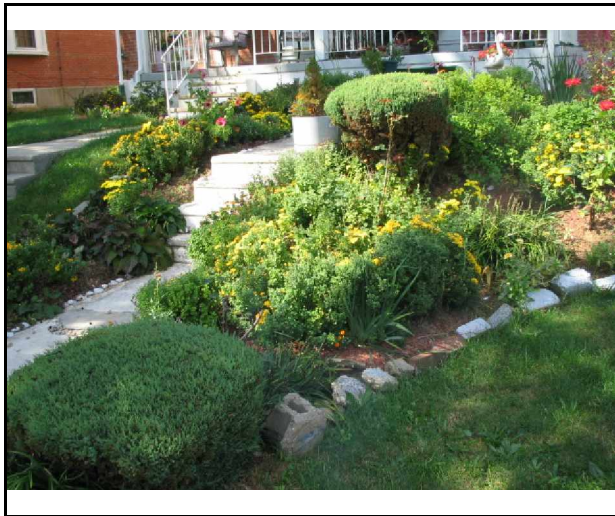
Photo No: 358

Unique Test ID	218	Date:	10/5/2004	MeterBasin:	01_WR07
Observer ID:	B	Crew:	T-2	Dye Test Recommended:	N
Defect No:	6	Setup No:	3	Priority CCTV:

House Number	3900	Street Prefix:		Street Name:	Brookhill	Street Type:	ROAD
Source Type:	04= Cleanout	Location:	7=Yard-Front	Severity:	4=Major		
Sector:	2=Private	Drainage Area:	0				
Comments:

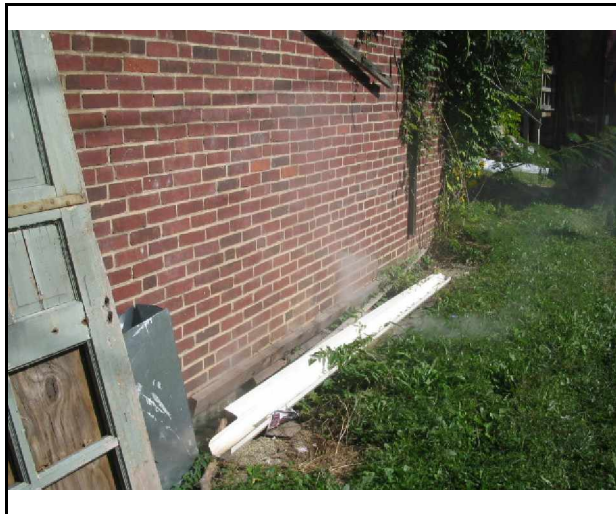
Photo No: 360

Unique Test ID	219	Date:	10/5/2004	MeterBasin:	01_WR07
Observer ID:	B	Crew:	T-2	Dye Test Recommended:	N
Defect No:	1	Setup No:	4	Priority CCTV:

House Number	3710	Street Prefix:		Street Name:	Clarinth	Street Type:	ROAD
Source Type:	02= Service Line	Location:	8=Yard-Back	Severity:	4=Major		
Sector:	2=Private	Drainage Area:	30				
Comments:

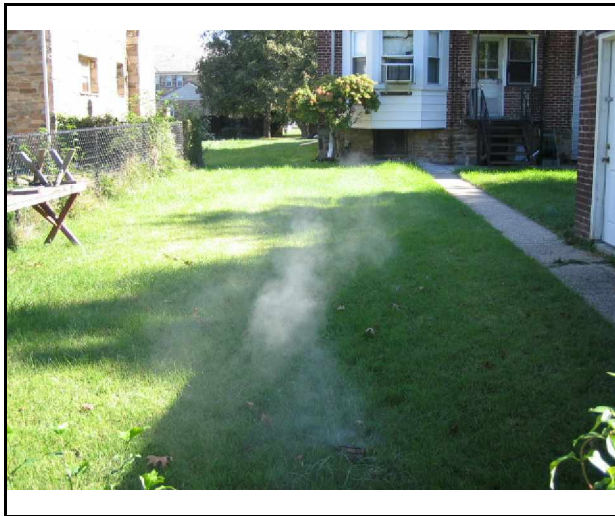
Photo No: 361

Unique Test ID	219	Date:	10/5/2004	MeterBasin:	01_WR07
Observer ID:	B	Crew:	T-2	Dye Test Recommended:	N
Defect No:	2	Setup No:	4	Priority CCTV:

House Number	3704	Street Prefix:		Street Name:	Clarinth	Street Type:	ROAD
Source Type:	04= Cleanout	Location:	8=Yard-Back	Severity:	4=Major		
Sector:	2=Private	Drainage Area:	0				
Comments:

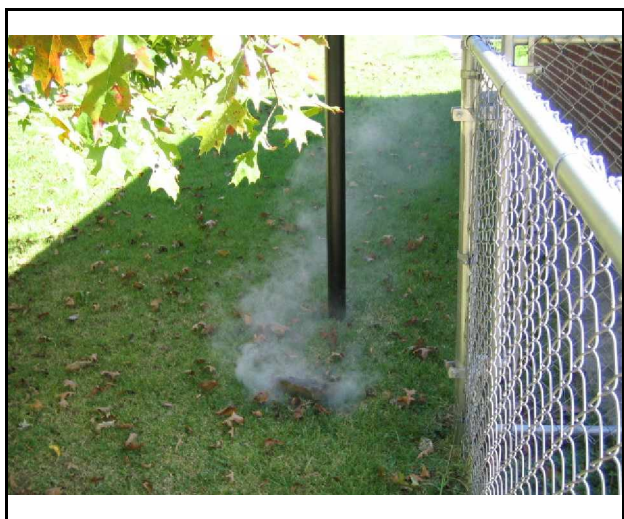
Photo No: 362

Unique Test ID	219	Date:	10/5/2004	MeterBasin:	01_WR07
Observer ID:	B	Crew:	T-2	Dye Test Recommended:	N
Defect No:	3	Setup No:	4	Priority CCTV:

House Number	Street Prefix:	Street Name:	Street Type:
3724		Clarinth	ROAD

Source Type:	04= Cleanout	Location:	8=Yard-Back	Severity:	4=Major
Sector:	2=Private	Drainage Area:	0

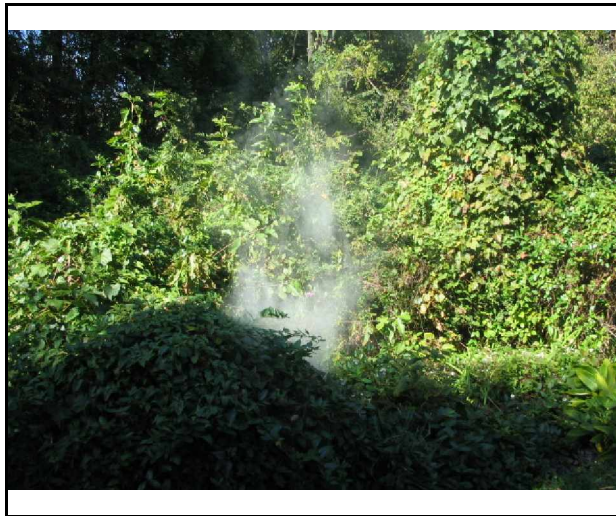
Photo No: 363

Unique Test ID	219	Date:	10/5/2004	MeterBasin:	01_WR07
Observer ID:	B	Crew:	T-2	Dye Test Recommended:	N
Defect No:	4	Setup No:	4	Priority CCTV:

House Number	Street Prefix:	Street Name:	Street Type:		
3728		Clarinth	ROAD		
Source Type:	02= Service Line	Location:	8=Yard-Back	Severity:	4=Major
Sector:	2=Private	Drainage Area:	16		
Comments:

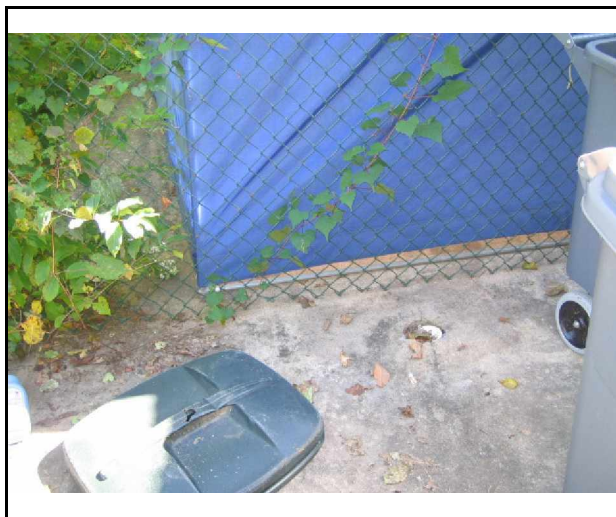
Photo No: 364

Unique Test ID	219	Date:	10/5/2004	MeterBasin:	01_WR07
Observer ID:	B	Crew:	T-2	Dye Test Recommended:	N
Defect No:	5	Setup No:	4	Priority CCTV:

House Number	3732	Street Prefix:		Street Name:	Clarinth	Street Type:	ROAD
Source Type:	04= Cleanout	Location:	8=Yard-Back	Severity:	4=Major		
Sector:	2=Private	Drainage Area:	1				
Comments:

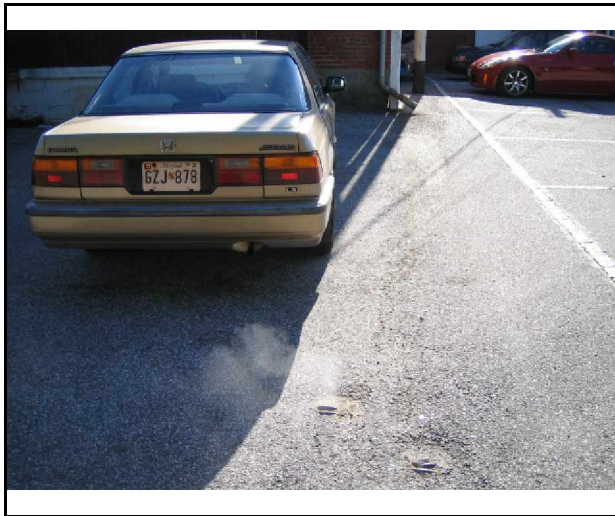
Photo No: 366

Unique Test ID	220	Date:	10/5/2004	MeterBasin:	
Observer ID:	B	Crew:	T-2	Dye Test Recommended:	N
Defect No:	1	Setup No:	5	Priority CCTV:

House Number	Street Prefix:	Street Name:	Street Type:
6711		Reisterstown	ROAD

Source Type:	04= Cleanout	Location:	2=Paved Asphalt	Severity:	4=Major
Sector:	2=Private	Drainage Area:	700

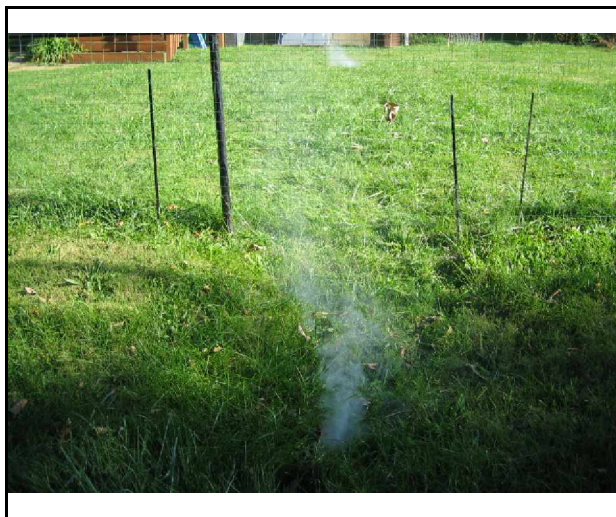
Unique Test ID	220	Date:	10/5/2004	MeterBasin:	01_WR07
Observer ID:	B	Crew:	T-2	Dye Test Recommended:	N
Defect No:	2	Setup No:	5	Priority CCTV:

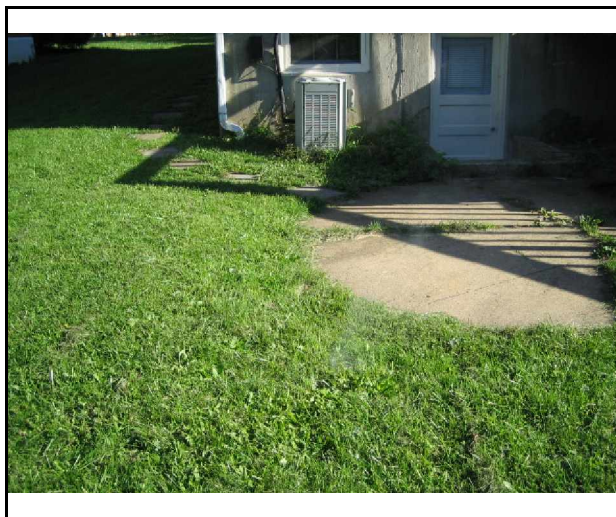
Unique Test ID	220	Date:	10/5/2004	MeterBasin:	01_WR07
Observer ID:	B	Crew:	T-2	Dye Test Recommended:	N
Defect No:	4	Setup No:	5	Priority CCTV:

House Number	Street Prefix:	Street Name:	Street Type:		
4000		Clarks	LANE		
Source Type:	04= Cleanout	Location:	8=Yard-Back	Severity:	3=Moderate
Sector:	2=Private	Drainage Area:	16		
Comments:

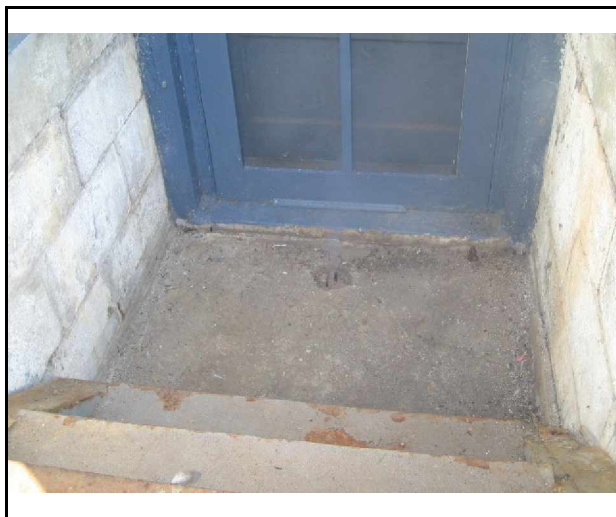
Unique Test ID	220	Date:	10/5/2004	MeterBasin:	01_WR07
Observer ID:	B	Crew:	T-2	Dye Test Recommended:	Y
Defect No:	5	Setup No:	5	Priority CCTV:

House Number	4002	Street Prefix:		Street Name:	Clarks	Street Type:	LANE
Source Type:	09= Stairwell Drain	Location:	8=Yard-Back	Severity:	4=Major		
Sector:	2=Private	Drainage Area:	9				
Comments:

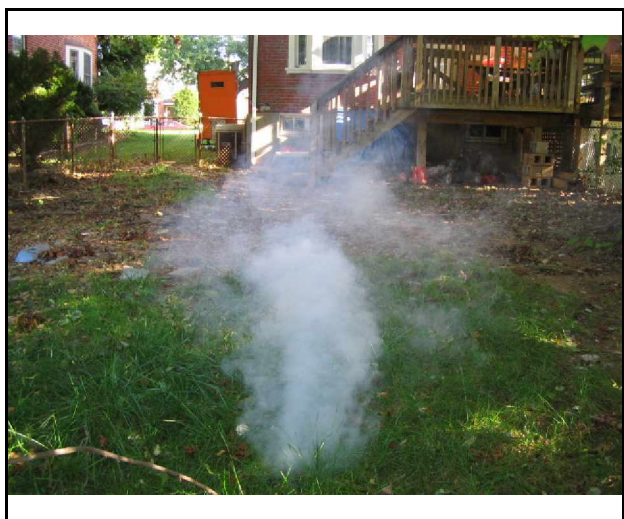
Unique Test ID	220	Date:	10/5/2004	MeterBasin:	01_WR07
Observer ID:	B	Crew:	T-2	Dye Test Recommended:	N
Defect No:	6	Setup No:	5	Priority CCTV:

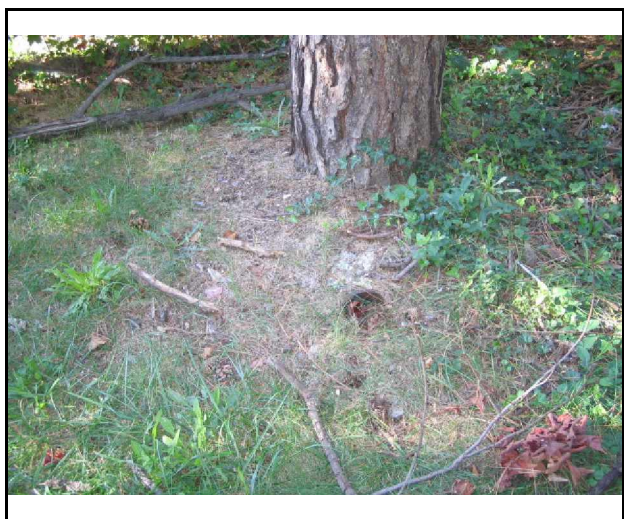
Unique Test ID	220	Date:	10/5/2004	MeterBasin:	01_WR07
Observer ID:	B	Crew:	T-2	Dye Test Recommended:	N
Defect No:	8	Setup No:	5	Priority CCTV:

House Number	3812	Street Prefix:		Street Name:	Clarks	Street Type:	LANE
Source Type:	04= Cleanout	Location:	8=Yard-Back	Severity:	3=Moderate		
Sector:	2=Private	Drainage Area:	16				
Comments:

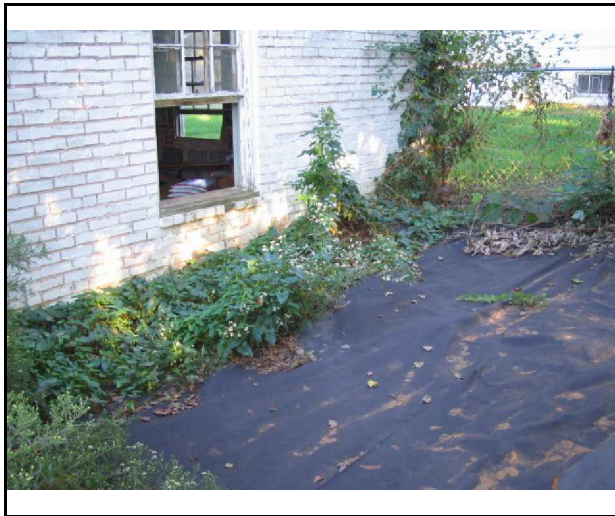
Unique Test ID	221	Date:	10/5/2004	MeterBasin:	01_WR07
Observer ID:	B	Crew:	T-2	Dye Test Recommended:	N
Defect No:	1	Setup No:	6	Priority CCTV:

House Number	3808	Street Prefix:		Street Name:	Clarks	Street Type:	LANE
Source Type:	02= Service Line	Location:	8=Yard-Back	Severity:	2=Trace		
Sector:	2=Private	Drainage Area:	25				
Comments:
